# Dating Barns in Holland Township, New Jersey with Dendrochronology

## Part 5 - The Rapp/Phillips Barn

by Carla Cielo, Architectural Historian, Historic Preservation Consultant, Designer,  
in conjunction with the Holland Township Historic Preservation Commission.

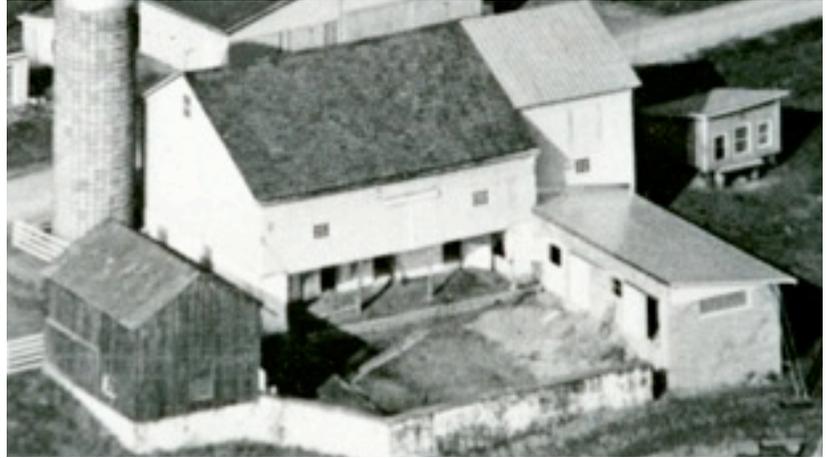
Pre 1953 photograph showing the Pennsylvania forebay bank barn (1844) with posted forebay and asymmetrical roof line.

The Rapp/Phillips barn is a Pennsylvania forebay bank barn (44' (l) x 31'-3" (w) x 24' (h)) incorporating the frame of an earlier 2-bay bank barn (25' x 25'). It has an asymmetrical roofline and a posted forebay (7'-9" deep) that mimics the appearance of a "Transitional Sweitzer" barn. Dendrochronology dated the forebay frame and the west gable end bent to 1844 at which time the farm was owned by Elias Rapp (1819-1894). The older two-bay frame is from 1824 at which time the farm was owned by Elias's grandfather Phillip H. Rapp but likely occupied by his son Joseph Rapp (Elias's father) and his family (see upper level plan). The Rapps were of German ancestry and were known for being carpenters.

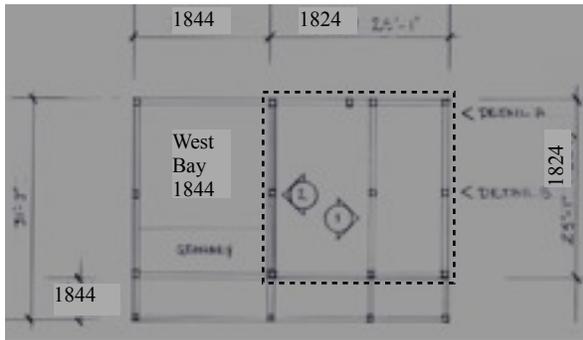
Upper level plan (the west bay and the forebay were added in 1844. The 1824 section is 25' square)

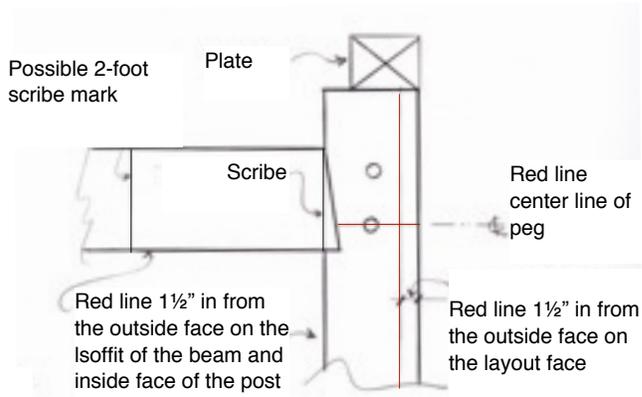
*Detail B, East gable end bent (outside face)*

The center post in the east gable end bent has four vertical red lines. On the outside face (layout face) there is a centerline and a line approximately 1½” in from the north side of the post. The north and south sides have vertical red lines 1½” in from the layout face aligning with the mortise insets. This post dendro dated to the spring of 1823.

The northeast post in the east gable end bent has a vertical red line on the layout face (east face) 1½” in from the north edge and a second vertical red line on the south face 1½” in from the layout face (aligns with a horizontal line on the soffit of the upper tie beam). It also has a horizontal line running through the center of the peg that secures the tenon at the upper tie beam (Detail B).

A horizontal red line is on the soffit of the upper tie beam in the east gable end bent 1½” in from the layout face. This line aligns with vertical lines on the inside faces of the north end and center posts in this bent. The upper tie beam also has a two-foot scribe mark and a vertical line scribed at the diminished shoulder (Detail B).

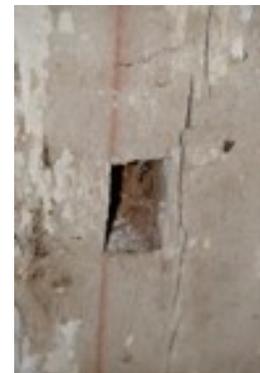
*Underside of a basement beam with a red snap line*

One of the basement beams (hewn top and bottom with the sides left round) has a red snap line aligning with mortise for a framed wall beneath it. The snap line stops about 2-feet in from the south end where the beam is hewn square. This beam dendro dated to the spring of 1823.

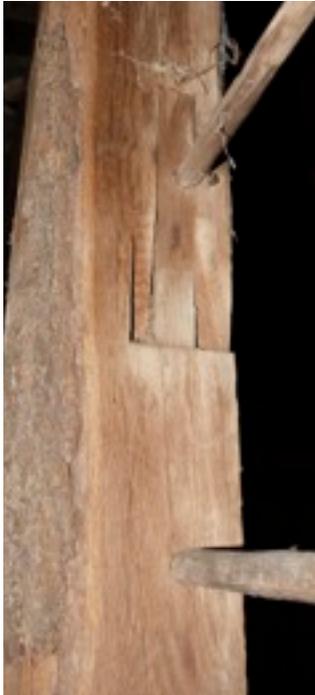
*Filled mortise supporting the rung of a ladder. A red snap line aligns with this mortise.*

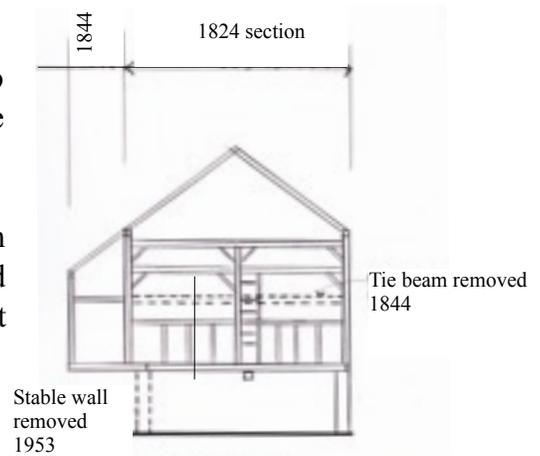
*Elevation 2: west center bent in the existing four bent configuration (originally the west gable end bent)*

Open and reused mortises (11" high and 6'-8" above the floor) in the end and center posts in the west bent indicate the removal of one interrupted tie beam (elevation 2). The mortises at the end posts were reused for braces. The mortise at the interior posts was filled with a wood block to support the rung of a ladder that was incorporated into the bent framing apparently in 1844. A red snap line aligns with the filled mortise. This confirms that the snap lines predate the 1844 renovations and are thereby original to the 1824 frame.

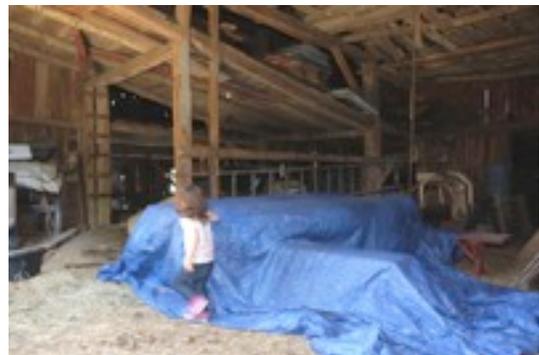
*Elevation 1: East center bent in the existing four bent configuration (originally the center bent). The loft floor was slanted to accommodate a threshing machine.*

The framing assembly of the center bent was also fitted with a ladder and was re-configured to slope the floor of the loft (higher on the banked side). According to the current owner, Mr. Bob Phillips who was in his 80s at the time of the discussion, the loft floor was sloped to increase the height under the loft for a threshing machine (Elevation 1). "The engine sat outside."
