Dating Barns in Holland Township, New Jersey with Dendrochronology Part 4 - the Nathaniel Britton Barn

*by Carla Cielo, Architectural Historian, Historic Preservation Consultant, Designer,
in conjunction with the Holland Township Historic Preservation Commission.*

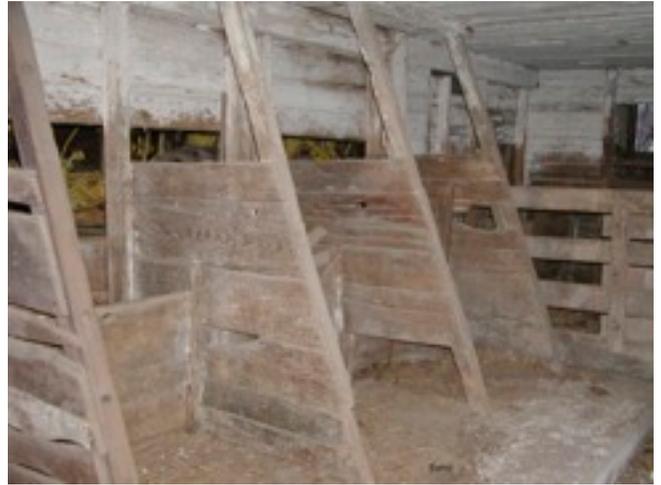
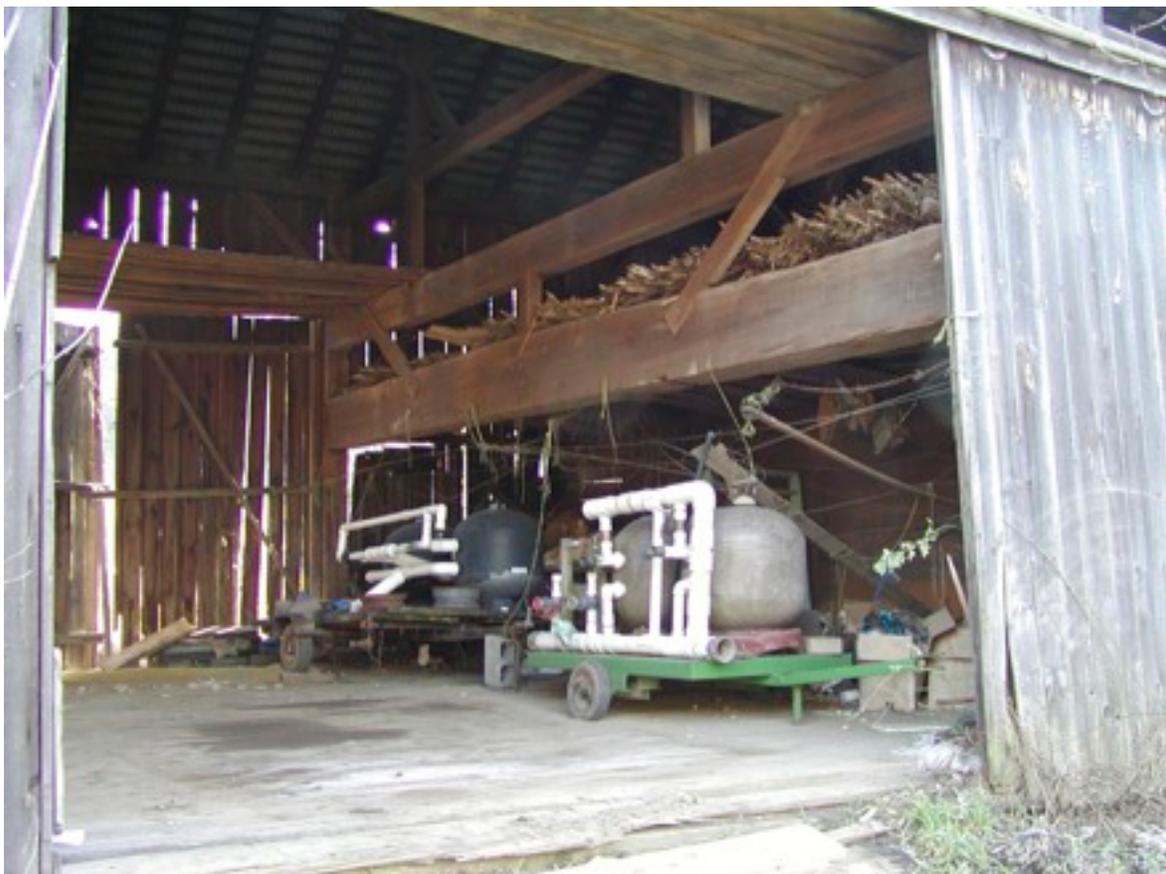
In addition to farming, Nathaniel operated a saw mill on his property and likely cut the timbers used to build this barn. The barn is framed almost entirely from hemlock floated down the Delaware River from either Pennsylvania or New York State. Most of the timbers are vertically sawn. Rectangular hemlock posts are roughly 8" x 10" with the wider dimension parallel to the ridge. The massive cambered hemlock swingbeam (22½" x 12" in the center and 20" x 12" at each end) is hewn on the sides and sawn on the top and bottom. The passing braces that join the upper, middle and lower tie beams in the swingbeam bent are oak, and the only oak members in the barn frame. Interestingly however, the mortise-and-tenon frames of the board-and-frame wagon doors are also oak. This is a combination scribe rule/square rule barn with two-foot scribe marks noted on the tiebeams and swingbeam. Rafters are sawn and joined to the corresponding rafter with a tongue-and-fork connection. This may be one of the earliest barns in Holland Township to be built almost entirely of hemlock and perhaps one of the latest barns to use scribe rule framing techniques.
